OV-1 MISHAP EXPERIENCE REPORT

FY 1972 through FY 1974

by
Mr. Paul R. Ewing

**Environmental Factors/Fixed Wing Division
Directorate for Aircraft Accident Analysis and Investigation**

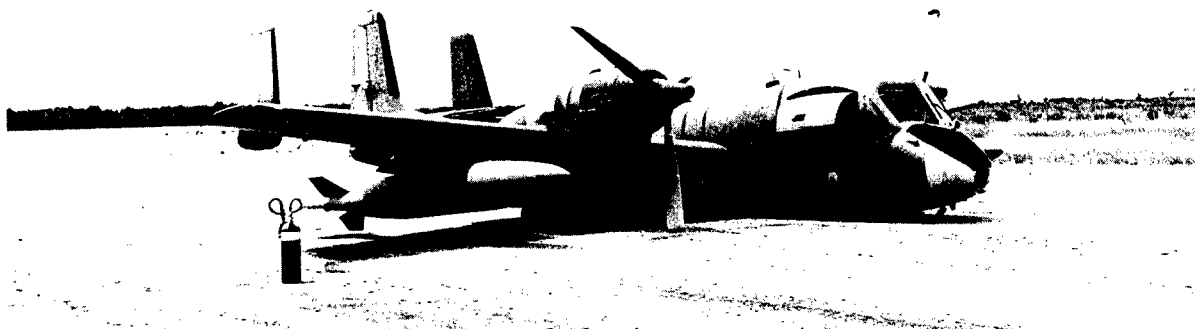
ACCIDENT NO. 4

ACCIDENT NO. 4—During training flight, IP gave pilot simulated single engine on takeoff. Pilot established single engine flight, flew the pattern, and landed without difficulty. During

the next traffic pattern, IP initiated simulated single engine as pilot was turning base leg. Landing gear was retracted and single engine flight was established. When landing was assured pilot extended gear and made prelanding check. Pilot turned final and aircraft was landed gear up. Aircraft slid to stop on runway and IP and pilot exited.

The suspected cause of this accident is that the rated student pilot initiated gear retraction during the final moments before touchdown, and the IP failed to recognize this soon enough. A suspected contributing factor is that the student pilot had a significant marital problem which was unresolved at time of accident. This could have served as a distracting influence.

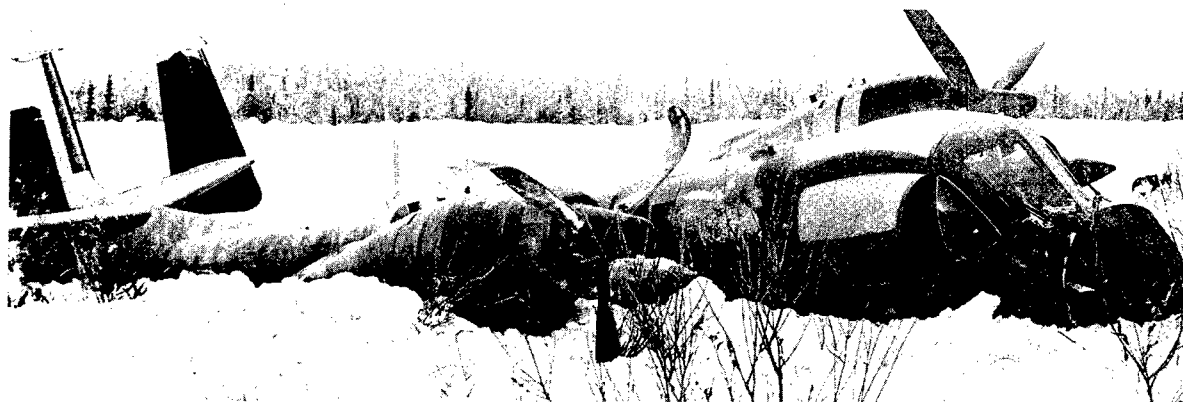
ACCIDENT NO. 6

ACCIDENT NO. 6—Pilot started aircraft and allowed temperatures to rise to normal. He then moved aircraft to runup area and performed normal runup, including cycling the propellers three times from low to high pitch. After approximately 20 minutes, pilot called for airport advisory and was given runway, winds, altimeter setting, and temperature. The runway surface condition was not included in the advisory. Pilot then taxied down runway 19 to avail himself of winds which favored runway 01. After he had taxied approximately 1,870 feet and attained a speed of 25 to 30 knots, he initiated the reverse check. At this time the No. 2 propeller failed to reverse. As rpm increased in both engines with No. 1 propeller in reverse and No. 2 at or near low pitch, aircraft began to turn to left. Pilot recognized the situation and began corrective action to realign aircraft on runway, applying right brake and rudder and moving

engine condition levers from reverse to ground idle position. This action had little effect on aircraft's ground track and pilot applied power to No. 1 engine in an attempt to check this movement, while continuing to apply right brake and rudder. At this point, aircraft had turned approximately 50° to 60° to left and pilot attempted to reverse propellers again. Realizing he had little or no control of aircraft at this point pilot began to prepare for impact. Both propellers were placed in feather position and aircraft departed runway 430 feet after initial application of reverse thrust and right main landing gear braking. Aircraft passed through an area of loose snow, crossed parallel access road, and skidded into large hard-packed snowbank.

The speed at which the aircraft was taxied before application of reverse thrust was excessive. The reason for the excessive speed was attributed to poor judgment on the part of the pilot and the lack of adequate ground reference points due to the snow-covered terrain. The application of differential power and the subsequent attempt to reverse only aggravated the already deteriorating situation.

A break in a wire leading to the No. 2 propeller reversing switch located on the No. 2 engine condition lever rendered the system inoperative. It is suspected that extreme cold temperatures and continued flexing of the wire during previous normal operations caused it to break.
